*Simulation of the probable Cause of Collapse
of the First Pylon of the Ramesseum*

SIMULATION OF THE PROBABLE CAUSES OF COLLAPSE OF THE FIRST PYLON OF THE RAMESSEUM [Pl. VI-VII]

Hany HELAL *

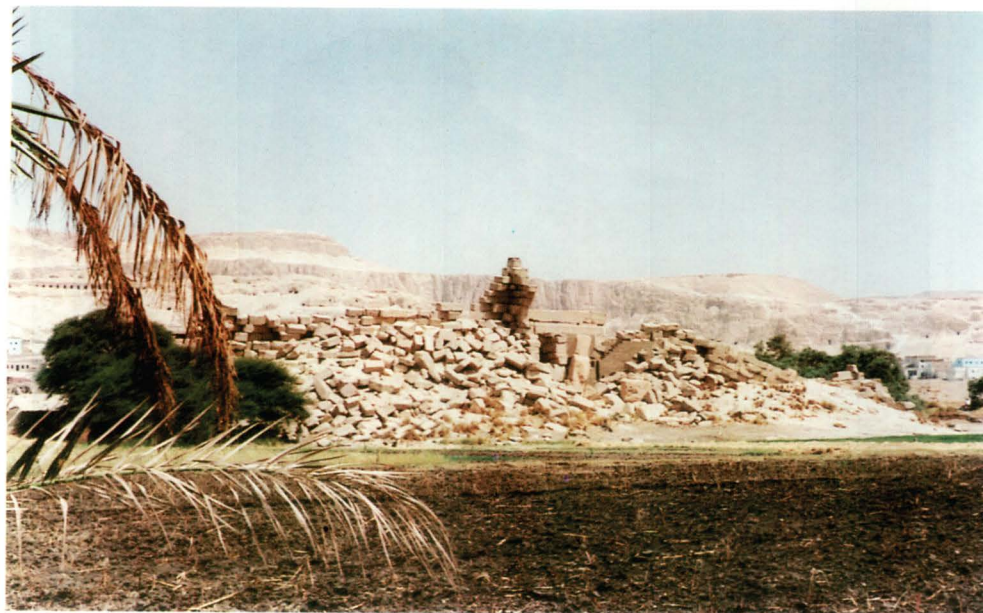
The main entrance wall of the temple called by the Greek, "Pylon" is actually collapsed. It's eastern wall is completely failed (Pl. VI-A) while the western one has, till now its principal elements (Pl. VI-B), but it has been subjected also to severe deformation and distortion (Pl. VII), to the extent that its probable failure could be expected.

A.- Eastern side of the first pylon. (Cliché Hany Helal).

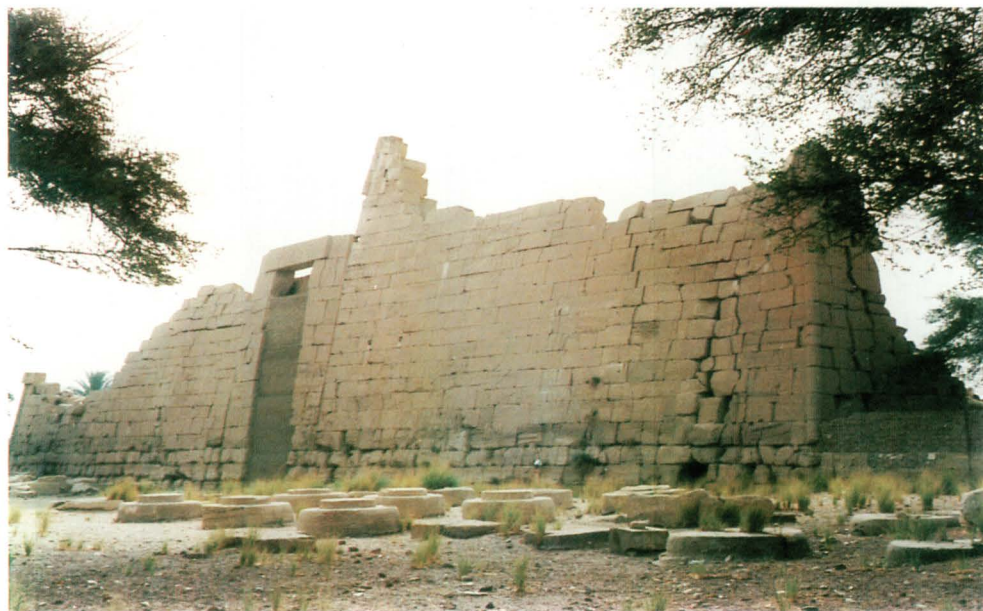
B.- Western side of the first pylon. (Cliché Hany Helal).
